CATEGORY 1.01

1.01 Inaccuracy of standing data (key Meter Technical Detail (MTD) data fields) held by Data Collector (DC)

Elexon has highlighted three root causes for Category 1.01 non-compliances in the Technical Assurance of Metering (TAM) 2019/20 audit. Please note that three non-compliances are awaiting rectification, as such have not yet had a root cause assigned.

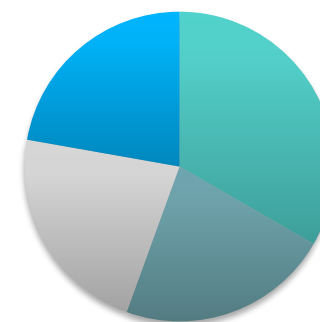
Category 1.01 Root Causes	SVA	CVA
Rectification in progress	3	
Incorrect evidence submission (correct data held at time of inspection)		2
Erroneous data entry during creation of MTDs	2	
Site incorrectly registered as non-complex	2	
Total	7	2

- Rectification in progress
- Incorrect evidence submission
- Erroneous data entry during creation of MTDs
- Incorrectly flagged as non-complex on MTDs

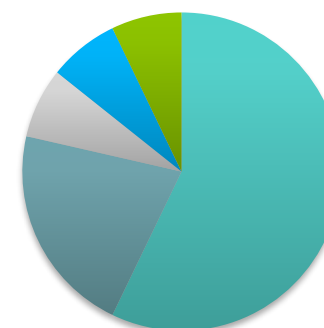
Category 1.02 Root Causes	SVA	CVA
Rectification in progress	8	
Closed CT link in substation	3	
BNO wiring error on installation	1	
Meter screen blank	1	
Blown fuse	1	
Total	12

- Rectification in progress
- Closed CT link in substation
- BNO wiring error on installation
- Meter screen blank
- Blown fuse

Elexon has highlighted three root causes for Category 1.02 non-compliances in the Technical Assurance of Metering (TAM) 2019/20 audit. Please note that 16 non-compliances are awaiting rectification, as such have not had a root cause assigned.

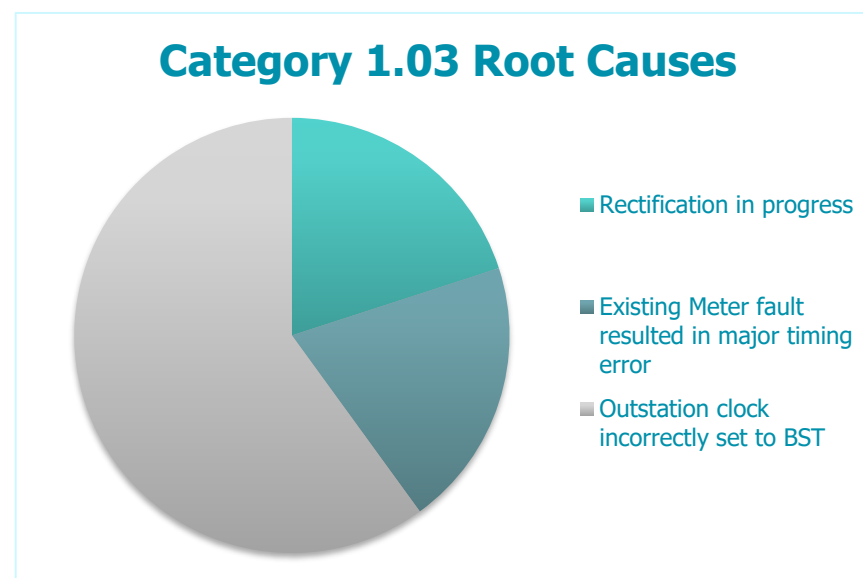
Category 1.03 Root Causes	SVA	CVA
Rectification in progress	1	
Existing Meter fault resulted in major timing error	1	
Outstation clock incorrectly set to BST	3	
Total	5

Elexon has highlighted two root causes for Category 1.03 non-compliances in the Technical Assurance of Metering (TAM) 2019/20 audit. Please note that one non-compliance is awaiting rectification, as such it has not had a root cause assigned.

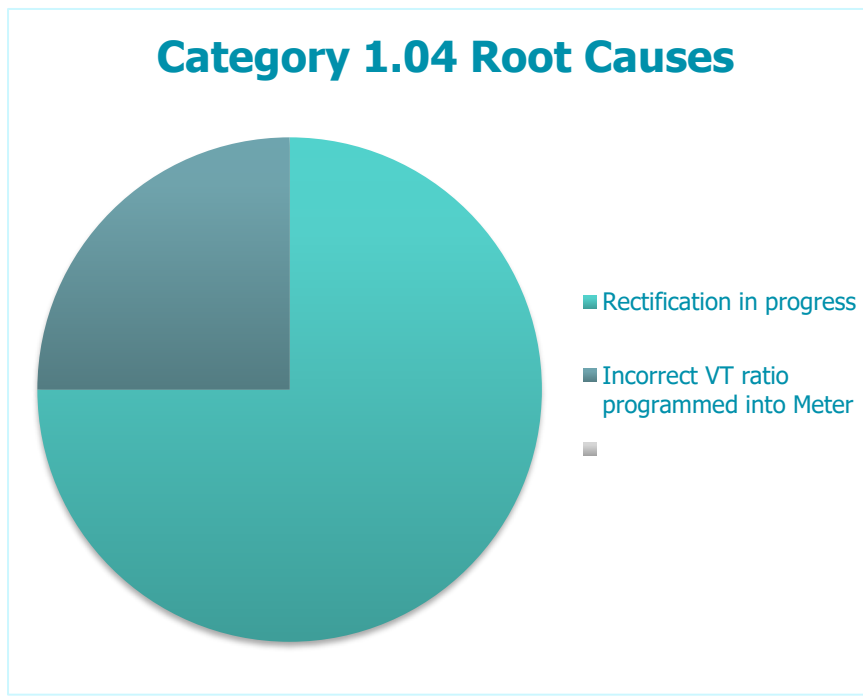
Category 1.04 Root Causes	SVA	CVA
Rectification in progress	3	
Incorrect VT ratio programmed into Meter	1	
Total	4

Elexon has highlighted one root cause for Category 1.04 non-compliances in the Technical Assurance of Metering (TAM) 2019/20 audit. Please note that three non-compliances are awaiting rectification, as such no root causes have been assigned.

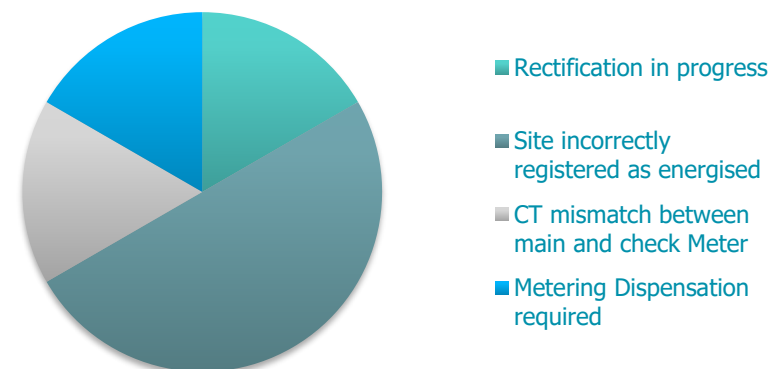
Category 1.06 Root Causes	SVA	CVA
Rectification in progress	1	
Site incorrectly registered as energised	3	
CT mismatch between main and check Meter	1	
Metering Dispensation required	1	
Total	4

Elexon has highlighted three root causes for Category 1.06 non-compliances in the Technical Assurance of Metering (TAM) 2019/20 audit. Please note that one non-compliance is awaiting rectification, as such no root cause have been assigned.
